LEE VALLEY REGIONAL PARK AUTHORITY
EXECUTIVE COMMITTEE
26 MARCH 2015 AT 10:00

E/398/15

LEE VALLEY MARINA – SPRINGFIELD AMENITIES PROJECT

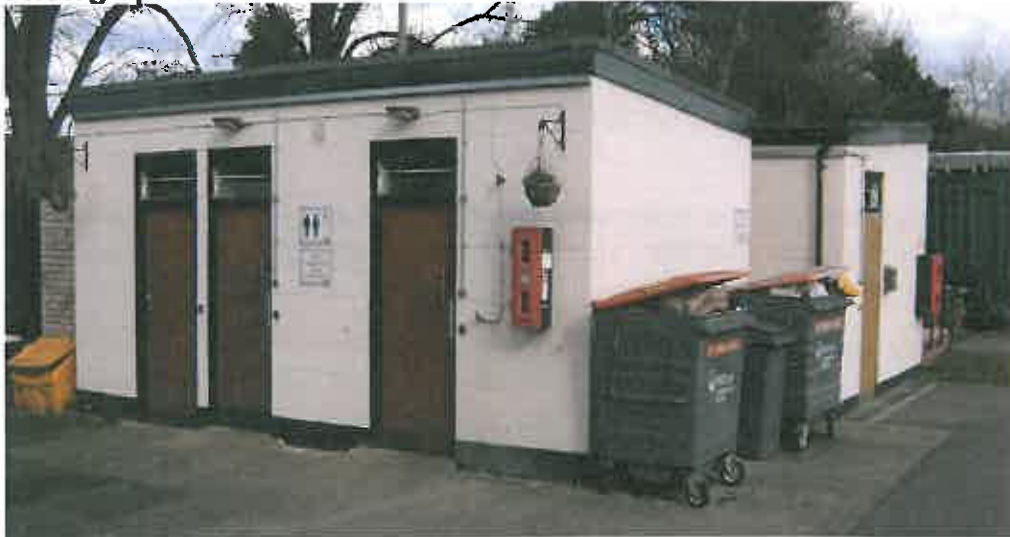
Photograph 1

- 7 The amenities are currently provided through three separate and disparate buildings which are grouped together as displayed in photograph 1 below.

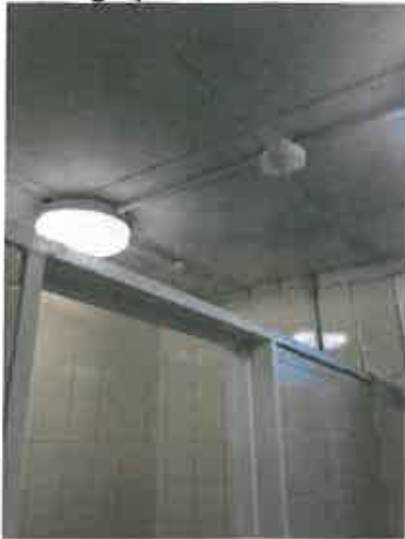
Photograph 2

- 8 The original amenities block, Block A, which was built in 1972 and consists of the services room, male and female showers and WC, and external access to the Elsan disposal point where customers empty their chemical toilets. The building is dated and in an extremely poor state of repair, as can be seen from photograph 2 below. The building suffers from insufficient heating and the current insulation and ventilation does not comply with current building regulations. The current location and specification of the Elsan disposal point presents health and hygiene issues.

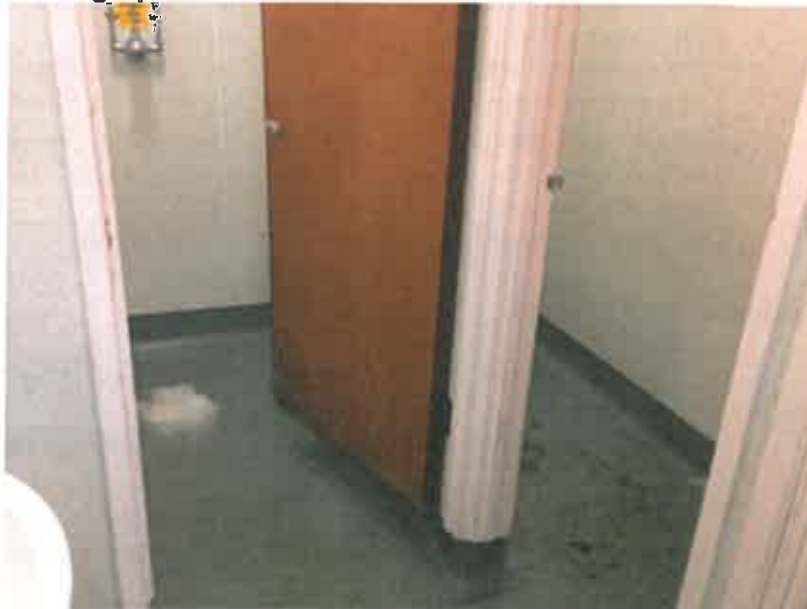
Photograph 3

- 9 The second amenity block, Block B, was added in the early 1990s directly adjacent to the original block, leaving a narrow external passageway between the buildings. Block B consists of male and female showers and WC, and laundry room. This building is in a very similar condition to Block A. Access to the male and female showers and WC is directly adjacent to the Elsan disposal point via the external narrow passageway. The building also suffers from insufficient heating and the current insulation and ventilation does not comply with current building regulations.
